ACCIDENT

Aircraft Type and Registration:	Team Himax 1700R, G-CCAJ	
No & Type of Engines:	1 Rotax 447 piston engine	
Year of Manufacture:	2003	
Date & Time (UTC):	30 August 2005 at 1216 hrs	
Location:	Rhigos, South Wales	
Type of Flight:	Private	
Persons on Board:	Crew - 1	Passengers - None
Injuries:	Crew - 1 (Serious)	Passengers - N/A
Nature of Damage:	Aircraft destroyed	
Commander's Licence:	Private Pilot's Licence	
Commander's Age:	67 years	
Commander's Flying Experience:	846 hours (of which 80 were on type) Last 90 days - 14 hours Last 28 days - 9 hours	
Information Source:	AAIB Field Investigation

Summary

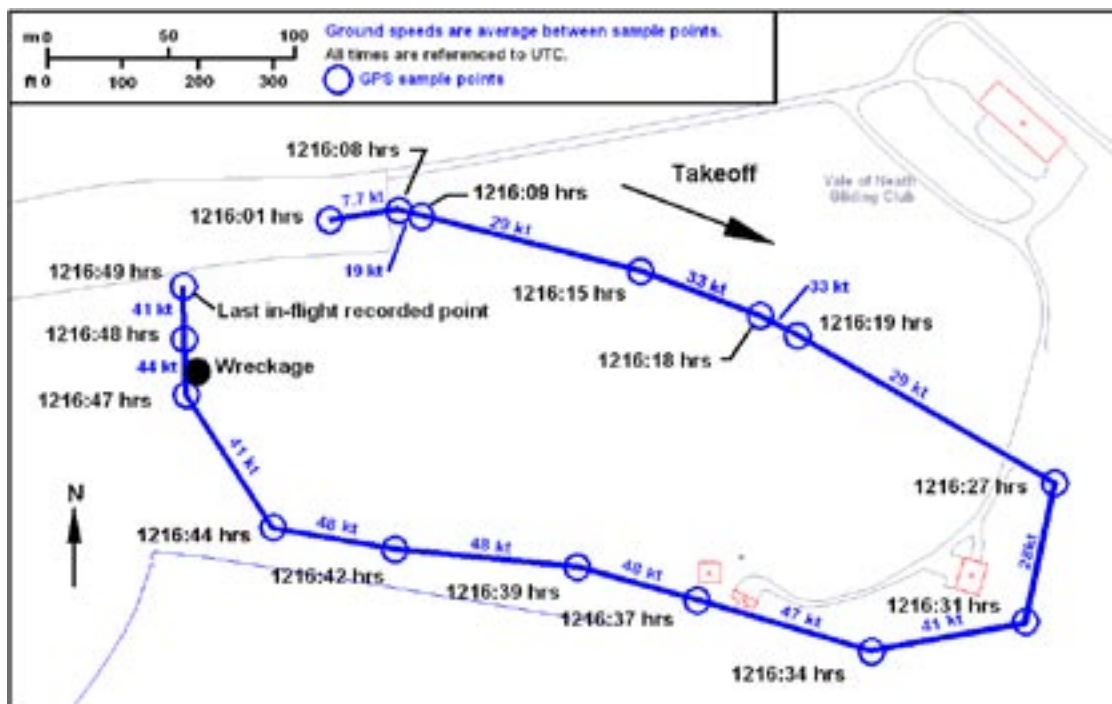
Figure 2
GPS plot

There were 11 track logs recorded on the GPS, the first recorded on 7 August 2005 and the last covered all the flying carried out on 30 August 2005. The flying on 30 August started at 0944 hrs near Gloucester. The aircraft landed at Rhigos at 1053 hrs. The take-off roll of the accident flight started at 1216:08 hrs with the aircraft's track varying between 107°M and 122°M. The aircraft became airborne and the ground speed peaked at approximately 33 kt. It then started to

decrease as the aircraft turned to the right, reducing to 28 kt on a track of 195°M. The ground speed then quickly increased to a maximum of 48 kt as the aircraft turned through west, reducing again to 41 kt as it then turned north. After this, no further track points were recorded. Figure 2 shows the GPS sample points of the final flight.

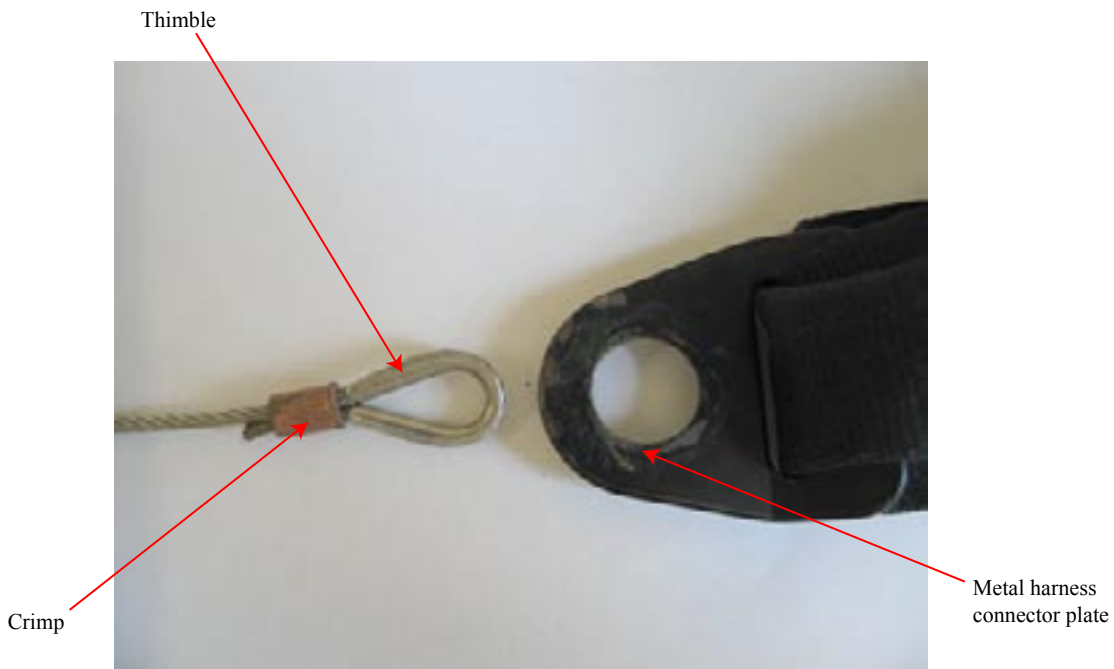
Figure 3

Connection of harness to cable (Note the thimble should be fitted over the lug of the harness connector, joining the cable directly to the connector plate)

by crimping the cable end around a thimble inserted through the lug of the harness connector plate. (Fig. 3) It did not indicate that the connector plates of the two shoulder straps should be constrained to stay together.

It was also observed that, at its forward end, the cable had not been connected to the shoulder straps in accordance with the design drawing. Instead both ends of the cable had been crimped around thimbles and both thimbles had then been connected to both shoulder straps using a single shackle passing through all four apertures. Whilst there was slight distortion to the pin in the shackle, the connection between the two straps remained intact. This deviation from the drawing had not been authorised by a concession issued by the PFA.

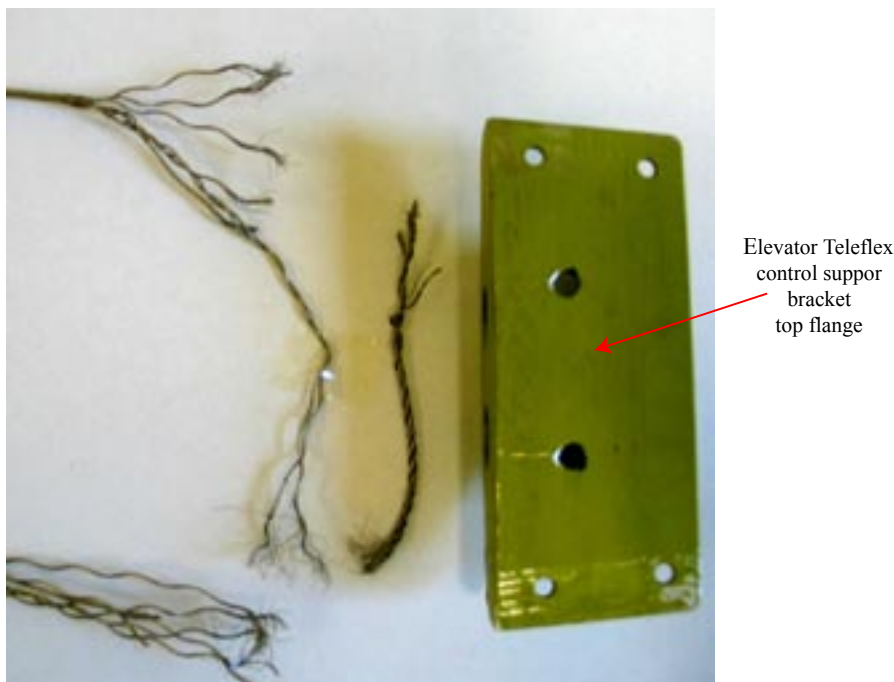
Figure 5

The shoulder harness attachment cable was found to have failed at the two points where it passed through the holes in the elevator Teleflex cable mounting bracket. (See Figure 5.) The failed shoulder harness cable and attachment bracket were subjected to further analysis.

Energy dispersive x-ray analysis of the cable material determined that the cable was stainless steel rather than the galvanised carbon steel specified in the design.

Further examination by optical and scanning electron microscope techniques revealed that the cable was in good condition with no evidence that any of the strands in the cable had broken or been subject to fretting prior to the accident. Assessment of the failure of individual strands indicated that the cable had failed in shear. It was concluded that the damage to the cable was consistent with a tensile load having been applied to the cable and the cable failing in shear at the edges of the holes where the cable turned through a tight radius.

Shoulder harness cable and elevator Teleflex cable mounting bracket

The PFA confirmed that the design called for a galvanised carbon steel cable rather than the stainless steel cable fitted to this aircraft. Notwithstanding this discrepancy, the damage to the cable indicates that it was a combination of the tensile load and the tight radius through which the cable turned around the holes

in the mounting bracket that caused it to fail in shear. It was considered unlikely that the change of material of the harness cable had significantly affected its mode of failure or the load at which it failed. Whilst the method used on this aircraft of securing the shoulder harness to the forward ends of the cable, by a shackle, had a number of advantages over that required by the design, there was no evidence that the owner had either sought a concession, or undertaken any analytical work before selecting the particular shackle used. It is considered, however, that the intent of this deviation from design resulted in the shoulder restraint being more effective by reducing the likelihood of the straps slipping sideways off the pilot's shoulder. The following recommendation is made in order to improve the effectiveness of the safety harness on the Team Himax and Minimax aircraft:

It is recommended that the Popular Flying Association reviews the design of the attachments of the shoulder harness and its securing cable in the rear fuselage of Team Himax and Minimax aircraft, to reduce the possibility of the shoulder harnesses slipping off the pilot's shoulders and to ensure that all bends in the restraining cable are of greater than the minimum bend radius recommended by the cable manufacturer and not routed over sharp edges.

Following circulation of this Report and Safety Recommendation, in draft form, the PFA has issued an approved modification (MOD/186/009) which introduces an improved fixing of the aft attachment of the harness cables.
